**PRELIMINARY ASSESSMENT/
VISUAL SITE INSPECTION**

**AKZO CHEMICALS, INC.
MCCOOK, ILLINOIS**

ILD 057 833 642

FINAL REPORT

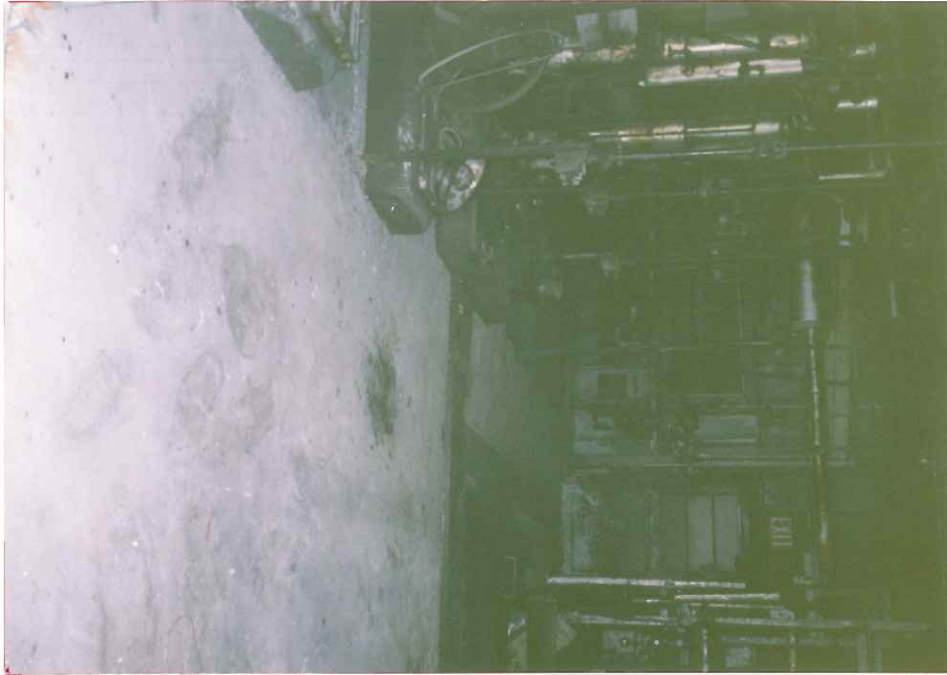
Location: SWMU 1
 Date: 08/09/91

The RCRA Hazardous Waste Storage Building and Pads were designed to hold 235,000 gallons of material (Photos 1, 2, 3, and 4). The building was the only unit that actually ever stored hazardous waste. The building is approximately 20 feet by 30 feet in size. The floor is made of concrete.

The building is maintained in the event that unforeseen activities require storage capacity. No evidence of current storage activities or release from this unit was observed.

Photograph No. 1
 Orientation: South
 Description: Inside of Storage Building

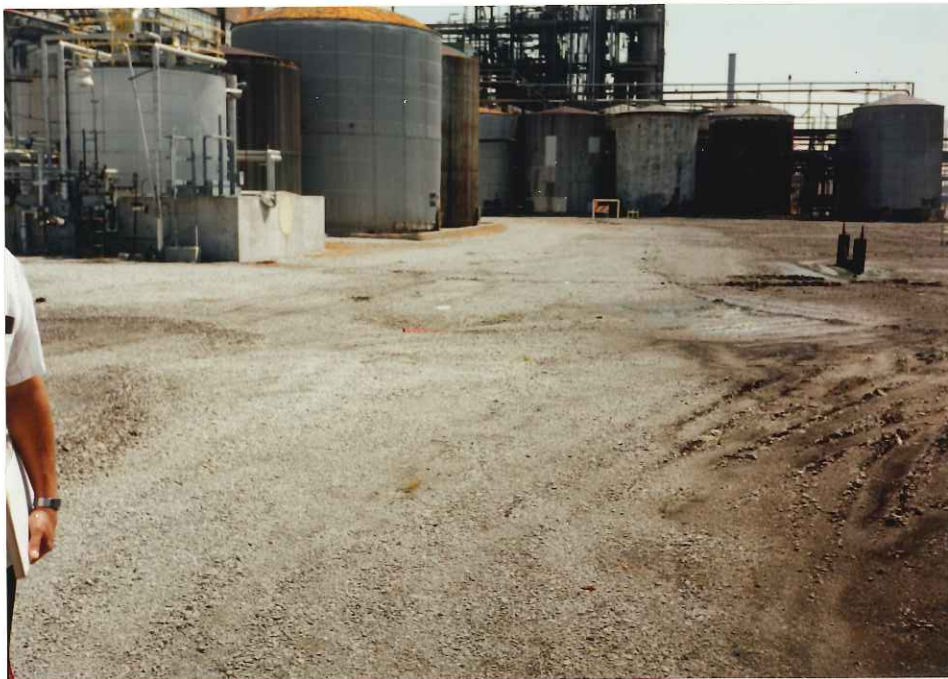
Location: SWMU 1
 Date: 08/09/91

Photograph No. 2
 Orientation: East
 Description: Number 1 Storage Pad Area

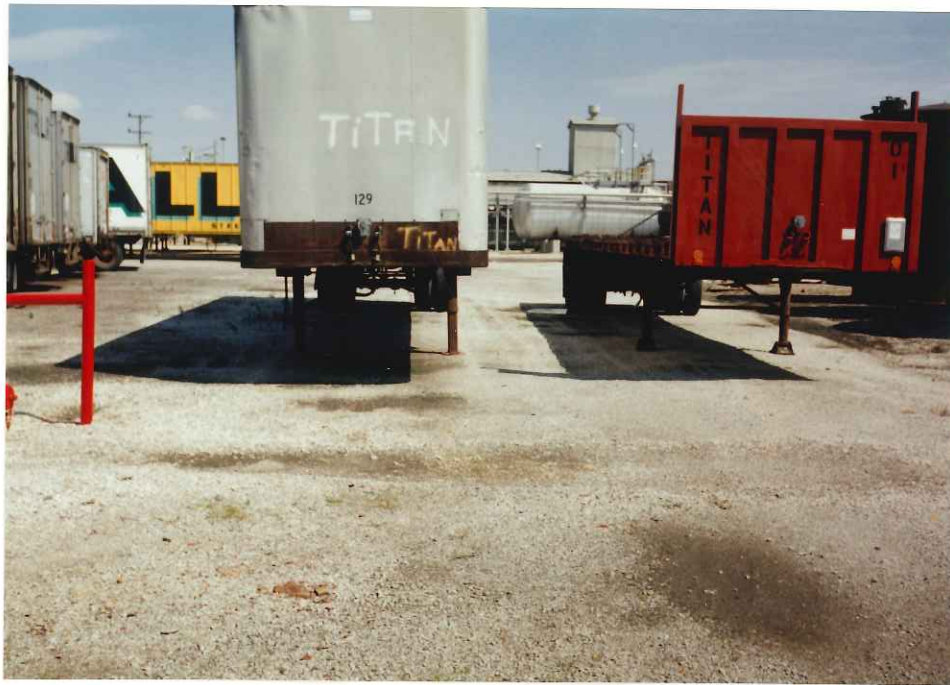
Location: SWMU 1
Date: 08/09/91

Photograph No. 3
Orientation: North
Description: Number 2 Storage Area

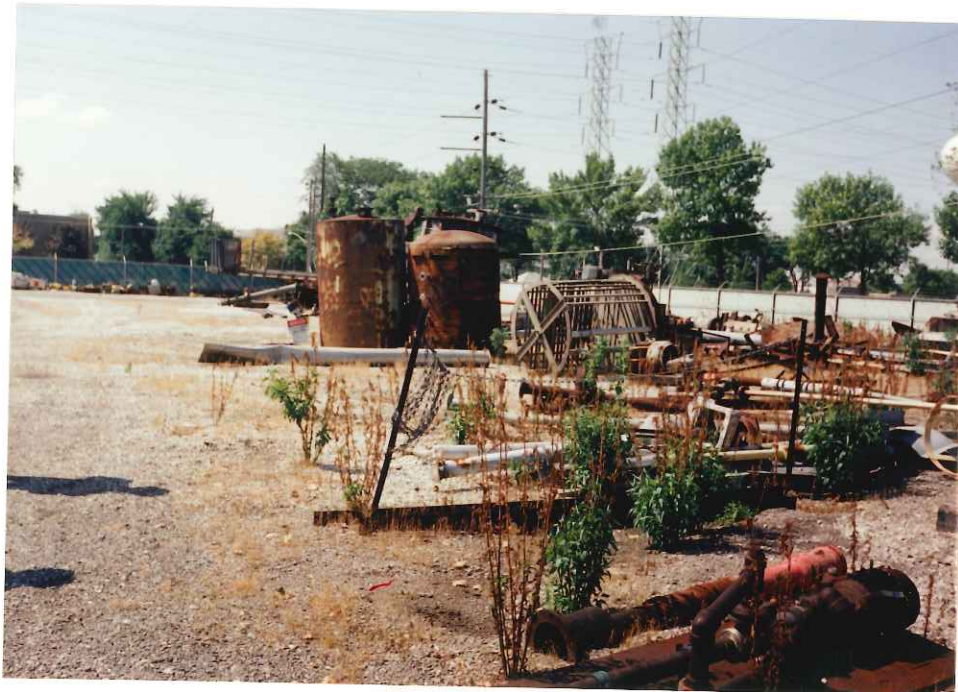
Location: SWMU 1
Date: 08/09/91

Photograph No. 4
Orientation: South
Description: Number 3 Storage Pad Area

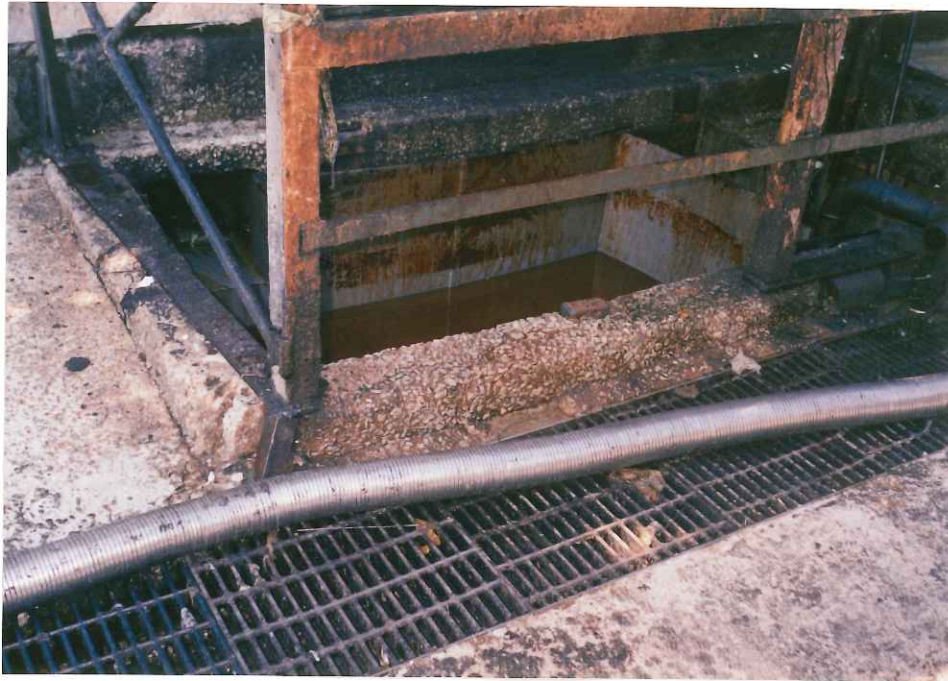
Location: SWMU 3
Date: 08/09/91

Photograph No. 5
Orientation: West
Description: Catch Basin

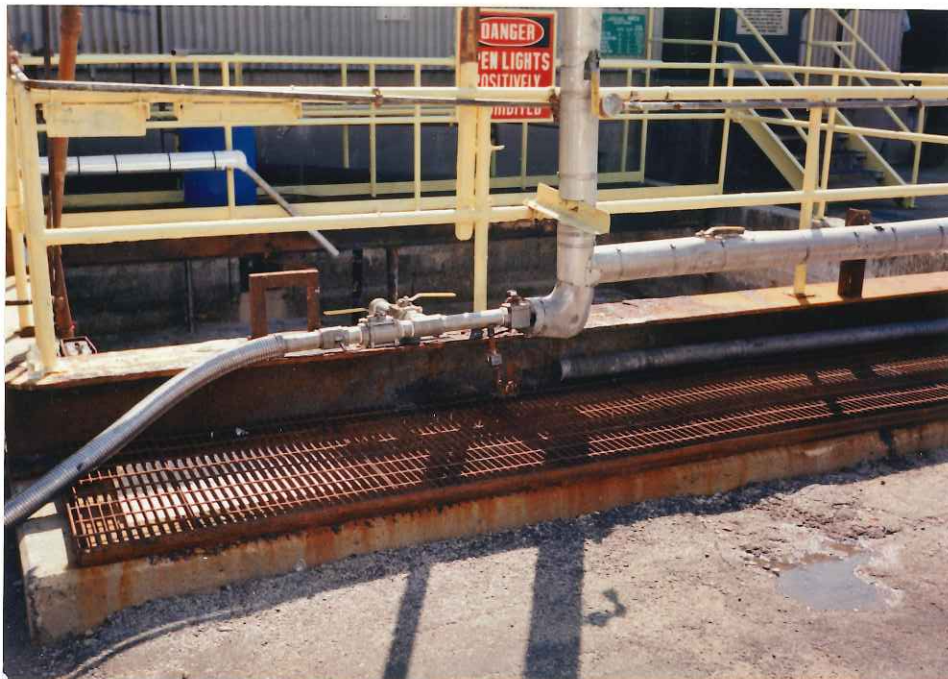
Location: SWMU 2
Date: 08/09/91

Observations: The units all appeared to function well as water, fatty acid separators. No evidence of releases was observed.

Photograph No. 6
Orientation: East
Description: Catch Basin

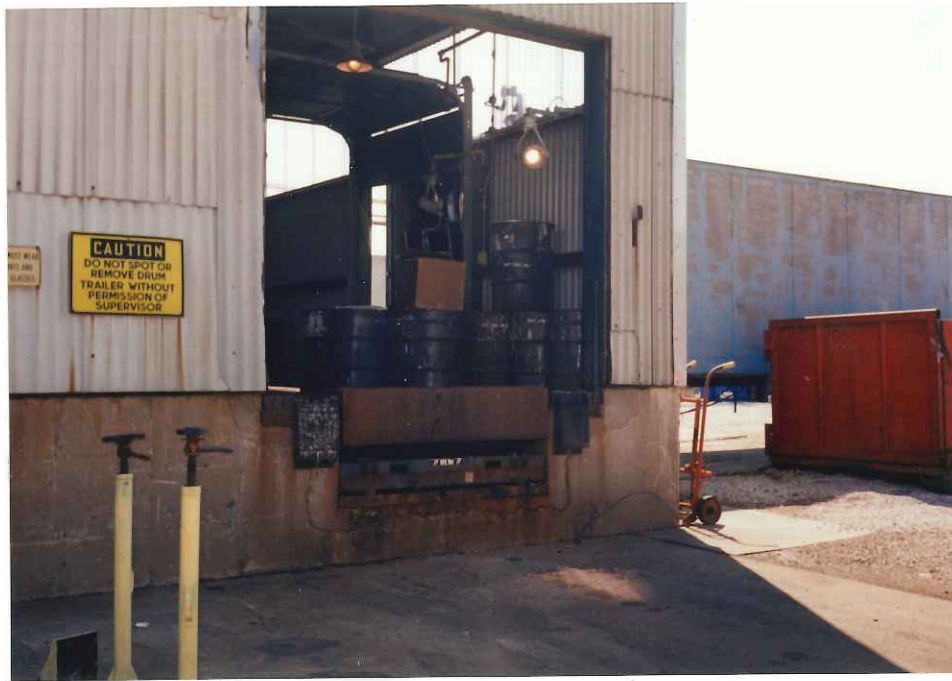
Location: SWMU 3
 Date: 08/09/91

Observations: This area appeared clean and compatible with drum storage. No evidence of releases was observed.

Photograph No. 7
 Orientation: Southeast
 Description: Salt Cake Drum Storage Area

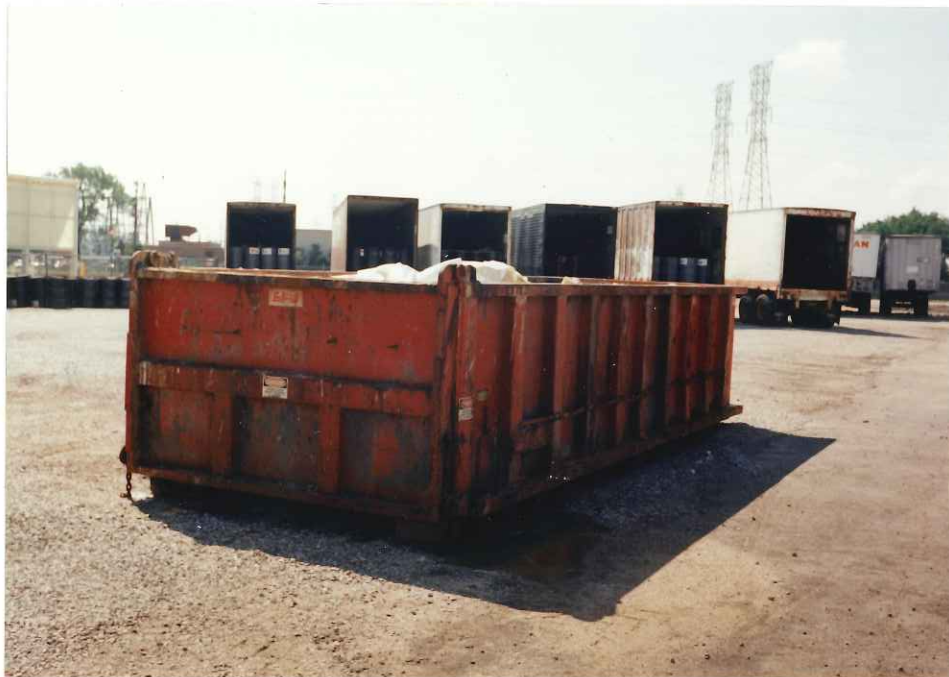
Location: SWMU 4
 Date: 08/09/91

Photograph No. 8
 Orientation: South
 Description: Salt Cake Dumpster

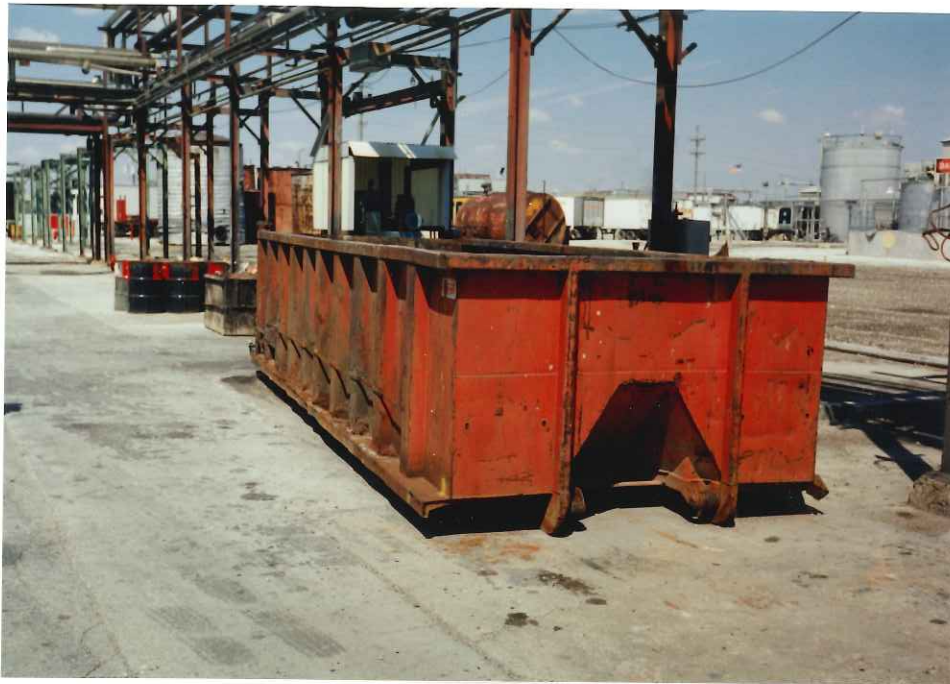
Location: SWMU 5
Date: 08/09/91

Photograph No. 9
Orientation: East
Description: Composite Solids Dumpster

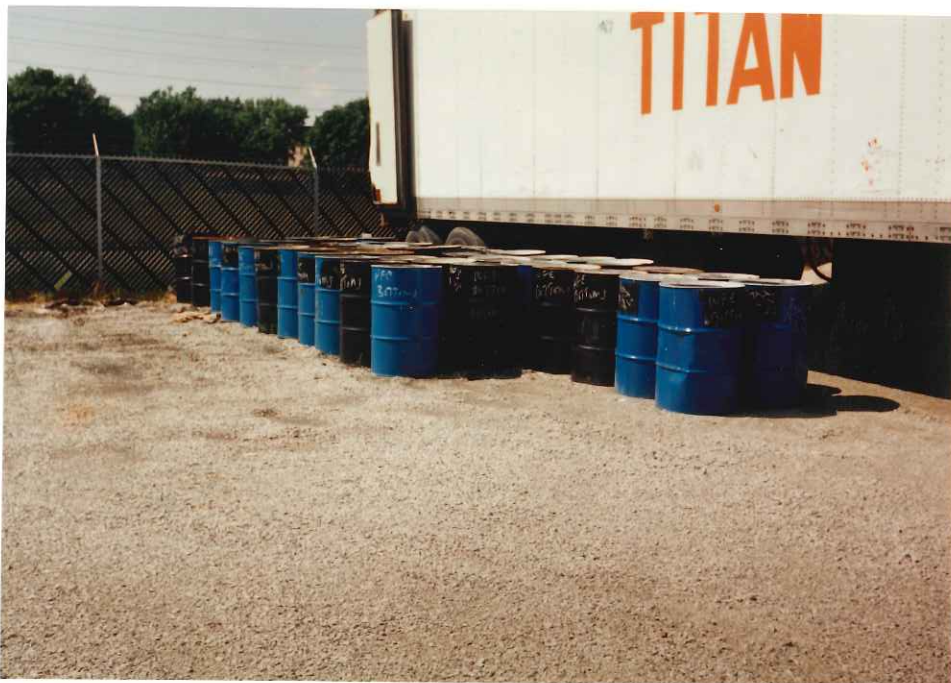
Location: SWMU 6
Date: 08/09/91

Approximately 50 closed drums were present on this SWMU. They all appeared to be in good condition. No evidence of releases was observed.

Photograph No. 10
Orientation: South
Description: Distillation Bottoms Storage Area

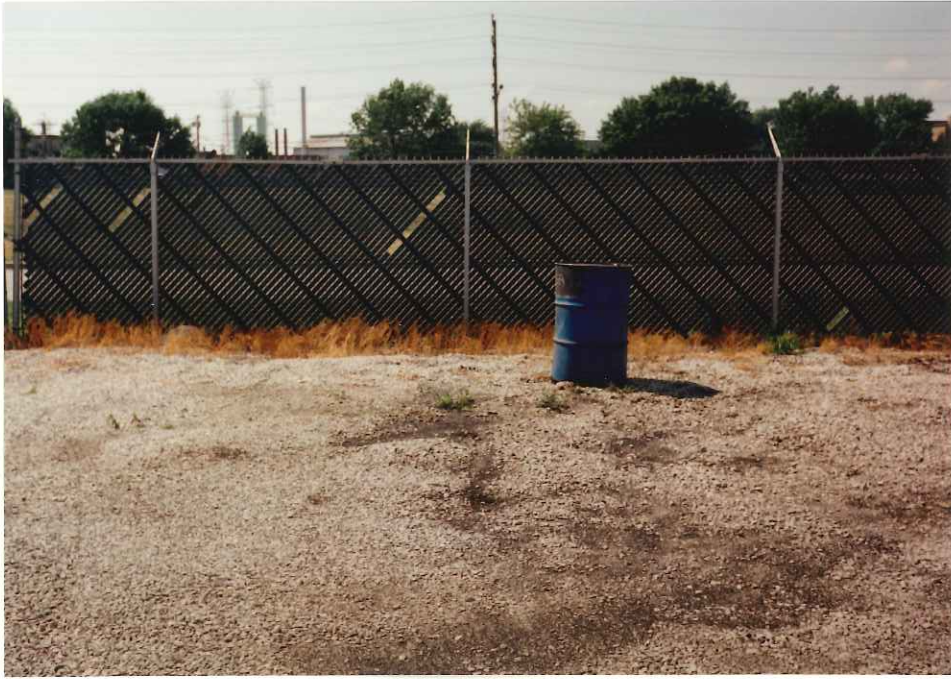
Location: SWMU 7
Date: 08/09/91

One closed drum was observed on this SWMU and it appeared to be in good condition. No evidence of releases from this unit was observed.

Photograph No. 11
Orientation: South
Description: Waste Oil Drum Storage Area

Recommendations: Because of the small volume of oil handled on the storage area, no further actions are recommended.

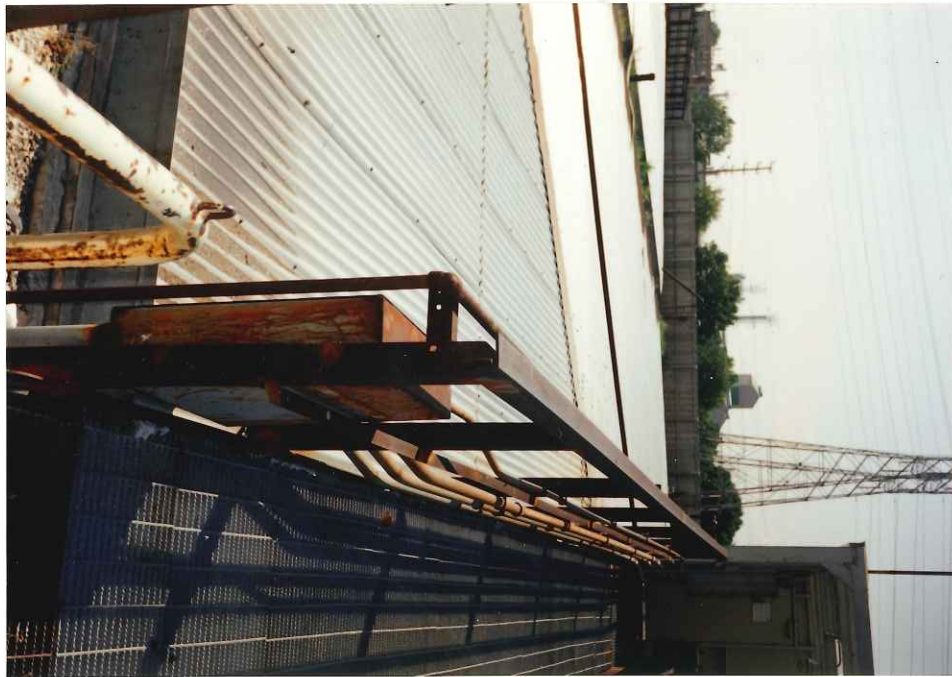
Location: SWMU 8
Date: 08/09/91

This SWMU was observed in operation without incident. No evidence of releases from this unit was observed.

Photograph No. 12
Orientation: South
Description: Waste Water Treatment Plant

Recommendations: No further actions are suggested.
